REPAIR, EVALUATION, MAINTENANCE, AND REHABILITATION RESEARCH PROGRAM

TECHNICAL REPORT REMR-CO-3

CASE HISTORIES OF CORPS BREAKWATER AND JETTY STRUCTURES

Report 1 SOUTH PACIFIC DIVISION

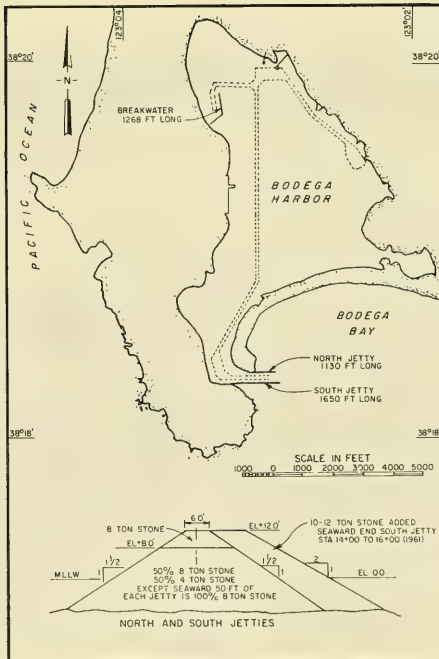
Figure 9. Bodega Harbor, California

Date(s)	Construction and Rehabilitation History
1943	The initial construction of the north and south jetties was completed at the site (Figure 9). The north and south jetties were rubble-mound structures with lengths of 1,130 and 1,650 ft, respectively, with crest els of +12 ft mllw and 1V:1.5H side slopes.
1961	Rehabilitation of the channels and south jetty was completed for a cost of \$399,800. Stone was added to the seaward side of the jetty between sta 14+00 and 16+00. The side slope of the structure over this 200-ft length was changed to 1V:2H.
1985	A 1,268-ft-long baffled-concrete pile breakwater was constructed by local interests in the northern portion of Bodega Harbor (Figure 9) to protect small craft moored there from damages resulting from wave action. The breakwater was approved for maintenance by the CE in November.
1986	The structures presently are in satisfactory condition.

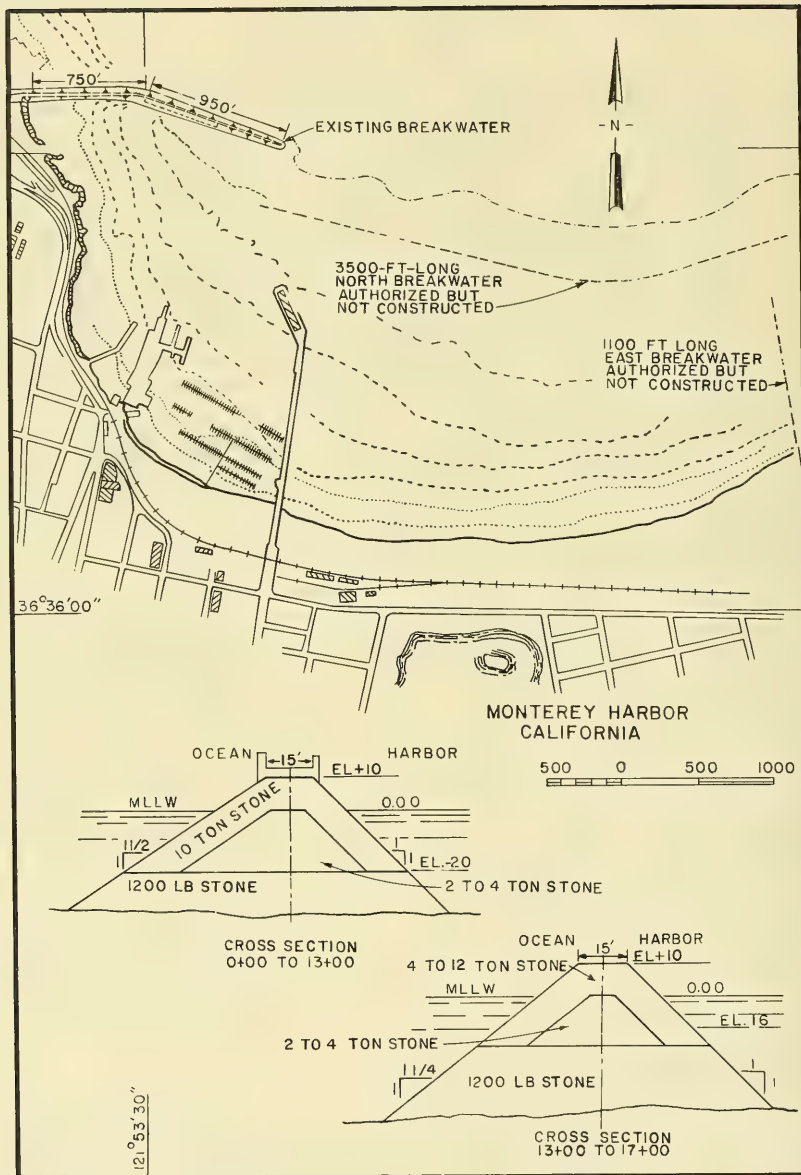
Figure 20. Monterey Harbor, California

<u>Date(s)</u>	<u>Construction and Rehabilitation History</u>
1932	The construction of a 1,300-ft-long rubble-mound breakwater was completed (Figure 20). The crest el of the structure was +10 ft mllw, and the side slopes were 1V:1H on the harbor side and 1V:1.5H on the ocean side. The armor stones used weighed 10 tons each.
1934	A 400-ft rubble-mound extension to the breakwater was built under the Public Works Administration Program (Figure 20). The extension was constructed with a crest el of +10 ft and with 1V:1H side slopes on the harbor side. Side slopes on the ocean side were 1V:1.25H from the existing ground to el -16 ft mllw and 1V:1.5H from el -16 to +10 ft mllw. Armor stones used ranged from 4 to 12 tons. Total cost of the breakwater through 1934 was \$652,951.
1960	Improvements consisting of a 3,300-ft-long north breakwater and a 1,100-ft-long east breakwater (Figure 20) were authorized. These structures were never constructed; however, model tests were conducted to optimize the improvements (Chatham 1968).

1969	Model tests for a proposed tribar breakwater section were conducted (Davidson 1969).
1974	The project authorized in 1960 was reclassified as inactive due to lack of local support.
1986	There is no history of maintenance of the breakwater, and it is in satisfactory condition.

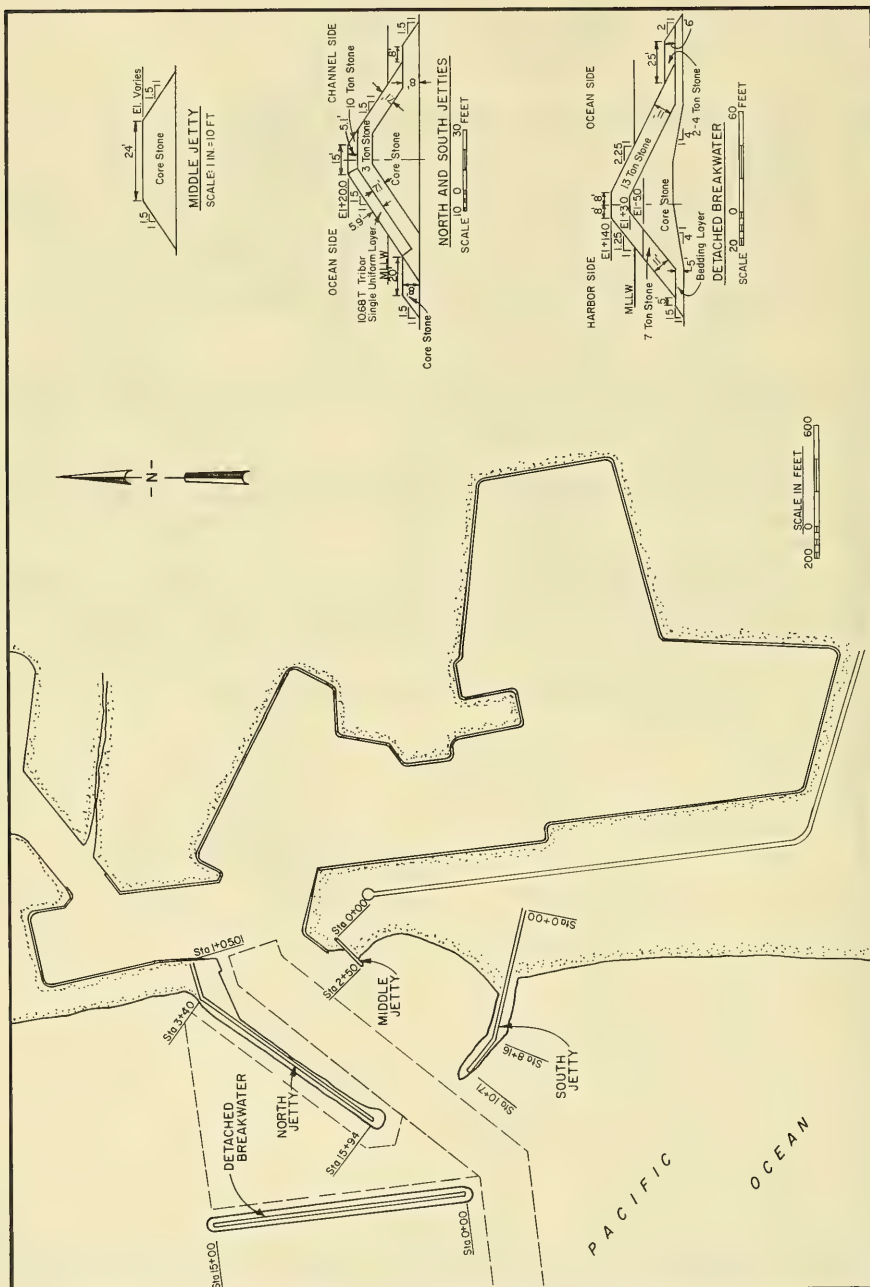
Figure 24. Ventura Marina, California

<u>Date(s)</u>	<u>Construction and Rehabilitation History</u>
1963	Construction of the marina was completed by local interests. Structures included a 1,254-ft-long north jetty, a 1,071-ft-long south jetty, and a 250-ft-long middle jetty (Figure 24). The north and south jetties were constructed with a crest el of +20 ft mllw and a crest width of 15 ft with 1V:1.5H side slopes. The ocean side of these jetties was armored with a single, uniform layer of 10.68-ton tribars. The middle jetty had a crest width of 24 ft with varying els and 1V:1.5H side slopes.
1968	A 1,500-ft-long detached rubble-mound breakwater and dredging of a sand trap were authorized. Also, the authorization plan provided for the US to maintain the existing jetties and channels previously constructed by local interests.
1971	Minor repairs were completed at the head of the north jetty. The repairs consisted of resetting displaced and broken tribars on the seaward end of the jetty and reshaping the jetty head with 3-ton stone.

1972	Construction of the 1,500-ft-long offshore rubble-mound breakwater authorized in 1968 was completed (Figure 24). The structure had a 16-ft-wide crest with an el of +20 ft mllw. Side slopes were 1V:1.25H on the harbor side and 1V:2.25H on the ocean side.
1986	The structures currently are in good condition.

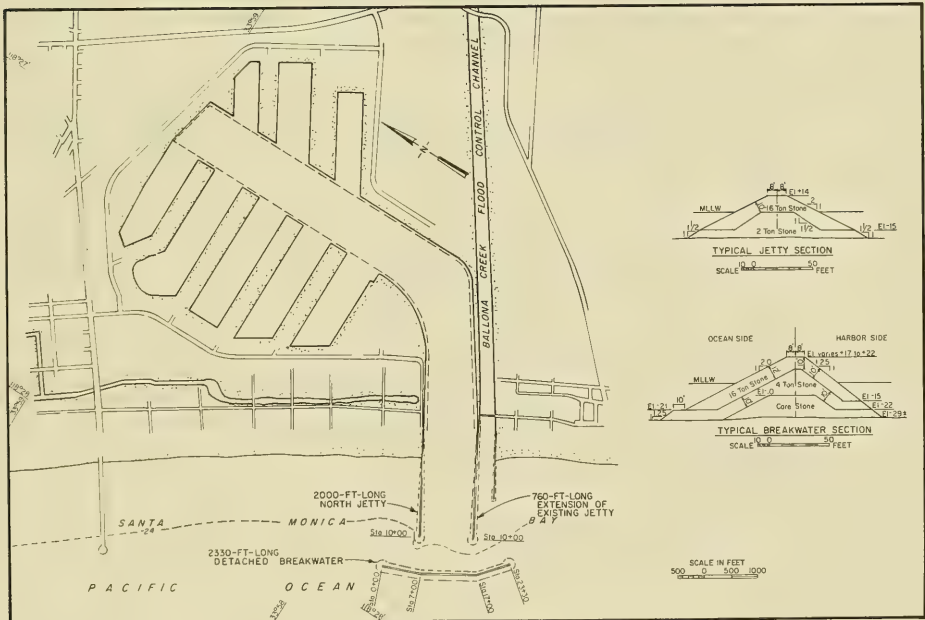
Figure 27. Marina Del Rey, California

Date(s)	Construction and Rehabilitation History
1965	Construction of a rubble-mound breakwater and two rubble-mound jetties was completed at the site (Figure 27). The breakwater was 2,330 ft long with a crest el varying from +17 to +22 ft mllw. The crest was 16 ft wide, and side slopes were 1V:2H on the ocean side and 1V:1.25H on the harbor side. The existing Ballona Creek north jetty was extended 760 ft in length and became the marina south jetty, and a 2,000-ft-long north jetty was constructed. The crest els of the jetties were +14 ft mllw with a width of 16 ft. Side slopes were constructed 1V:2H. The breakwater was model tested (Brasfeild 1965) and was necessary to reduce waves entering the wide entrance channel and reflecting off the vertical concrete perimeter walls to an acceptable level.
1986	The structures presently are in satisfactory condition.

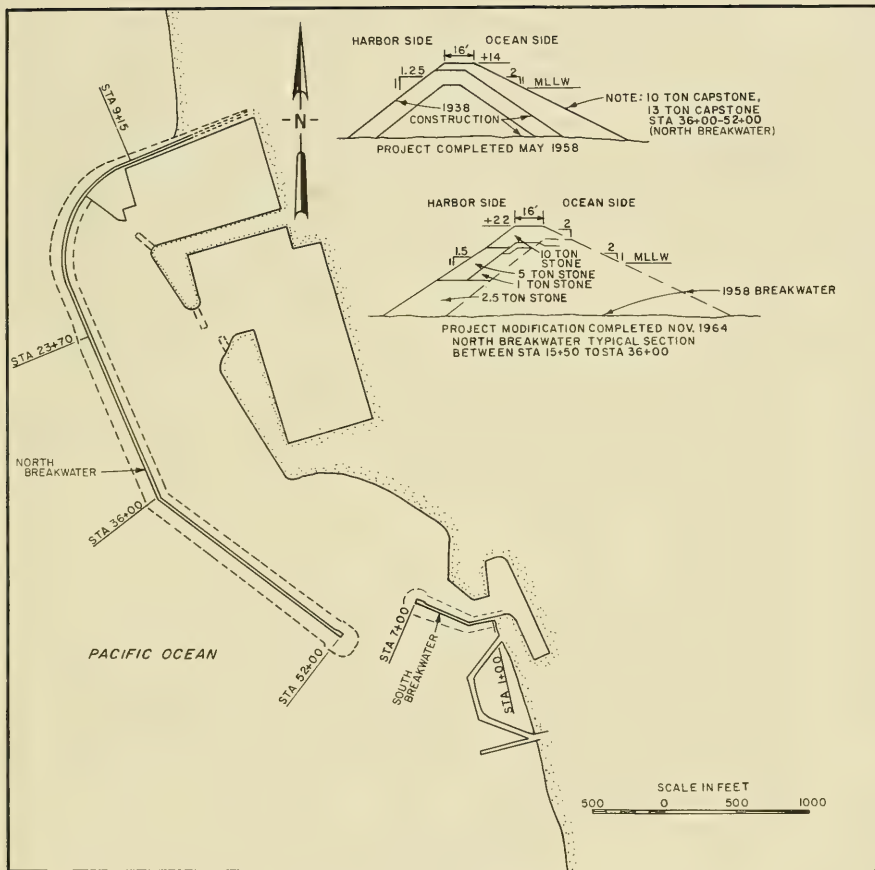
Figure 28. Redondo Beach King Harbor, California

<u>Date(s)</u>	<u>Construction and Rehabilitation History</u>
1938	Construction of a 4,285-ft-long permeable, rubble-mound breakwater (Figure 28) was completed.
1950	The breakwater became a Federal project, and improvements were authorized.
1958	Ten-ton capstones were placed on the ocean side of the breakwater on a 1V:2H slope, and the crest was raised to +14 ft mllw and increased to 16 ft in width. Thirteen-ton capstones were used on the breakwater between sta 36+00 and 52+00. A 600-ft-long south breakwater with a crest el of +14 ft was constructed. The structure has a 16-ft crest width, and side slopes were 1V:2H on the sea side and 1V:1.5H on the harbor side.
1960	Minor repairs to the north breakwater (from a storm in 1959) were completed.
1963	Storms demonstrated the inadequacy of the north breakwater for protecting small craft within the Harbor. While doing only minor damage to the breakwater, damage to small boats and Harbor facilities amounted to \$431,000.

1964	The north breakwater (between sta 15+50 and 36+00) was modified. The structure crest el was raised to +22 ft mllw at this location. Stones, ranging from 2.5 to 10 tons, were placed on the harbor side of the breakwater on a slope of 1V:1.5H (Figure 28).
1978- 1980	Storms of 1978 and 1980 resulted in damage to the north breakwater in nine areas with major voids occurring at sta 16+00 and 22+00.
1982	As a result of the damages in 1978 and 1980, the north breakwater was repaired at a cost of \$304,000.
1983	Storms resulted in significant damage at several locations along the north breakwater. The most significant was a breach 70 ft long, just south of the curved portion. Repair work was completed, and approximately 5,300 tons of new capstone and 1,700 tons of corestone were utilized. At seven additional locations, about 4,000 tons of capstone were replaced. The repair work cost approximately \$400,000.

1986	The breakwaters presently are in satisfactory condition.

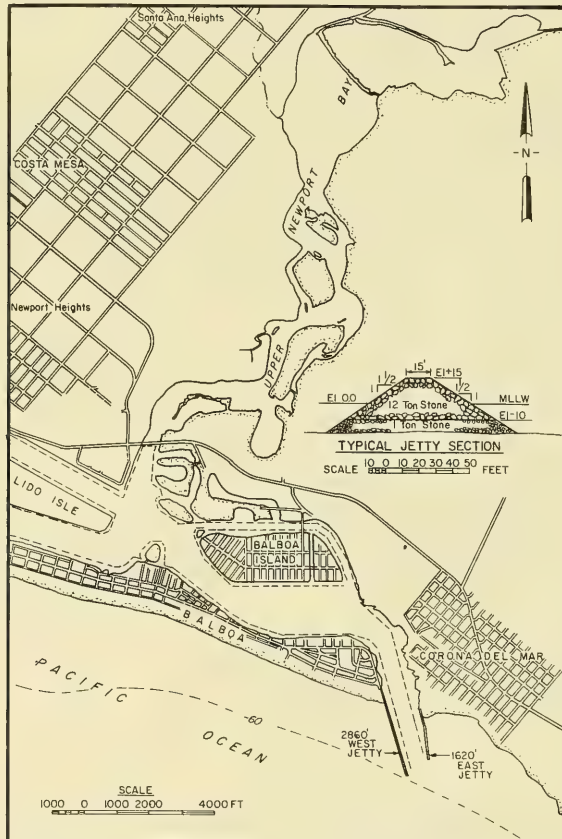
Figure 31. Newport Bay Harbor, California

<u>Date(s)</u>	<u>Construction and Rehabilitation History</u>
1934	Construction of two rubble-mound jetties at the site (Figure 31) was completed. The west and east jetties were 2,860 ft long and 1,620 ft long, respectively. The el of the structures was +15 ft mllw, and the crest width was 15 ft. Side slopes of 1V:1.5H on both ocean and harbor sides were used.
1986	Throughout the years, local interests have provided minor maintenance to the jetties, the extent of which is unknown. The jetties presently are in satisfactory condition.

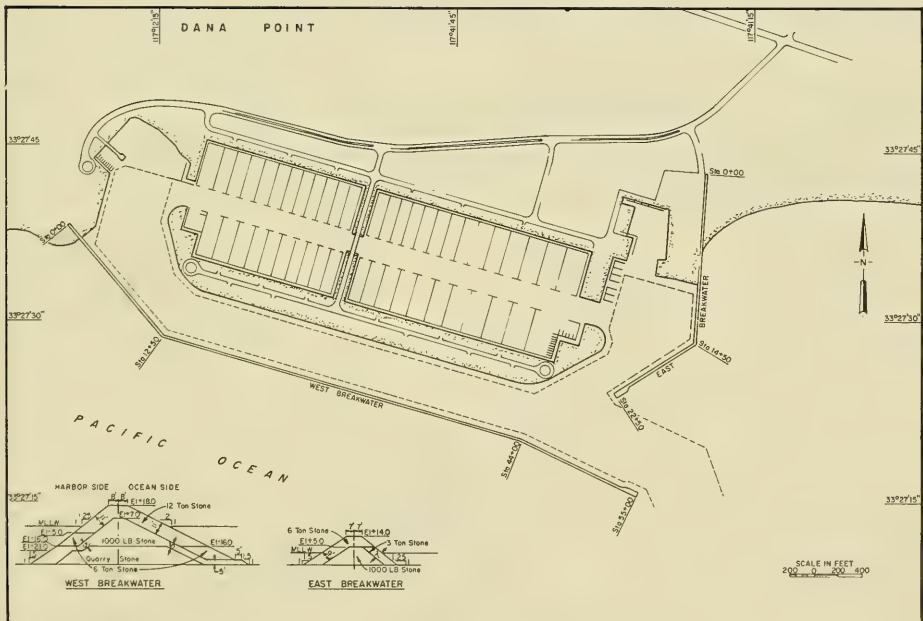
Figure 32. Dana Point Harbor, California

Date(s)	Construction and Rehabilitation History
1968	Construction of two rubble-mound breakwaters at the site (Figure 32) was completed. The west breakwater was 5,500 ft long with a 16-ft-wide crest at el of +18 ft mllw. The ocean side slope of the structure was 1V:2H, and the harbor side was 1V:1.25H. The east breakwater was 2,250 ft long with a 14-ft-wide crest width and a +14-ft el mllw. The ocean-side slope was 1V:1.5H, and the harbor-side slope was 1V:1.25H. Model tests were conducted for the project (Dai and Jackson 1966, Wilson 1966).
1983	Major storms resulted in approximately \$610,000 in damages to the breakwater.
1984	Restoration of the west breakwater in nine locations was completed. About 5,800 tons of capstone were used for this maintenance repair.
1986	The breakwaters are in satisfactory condition.

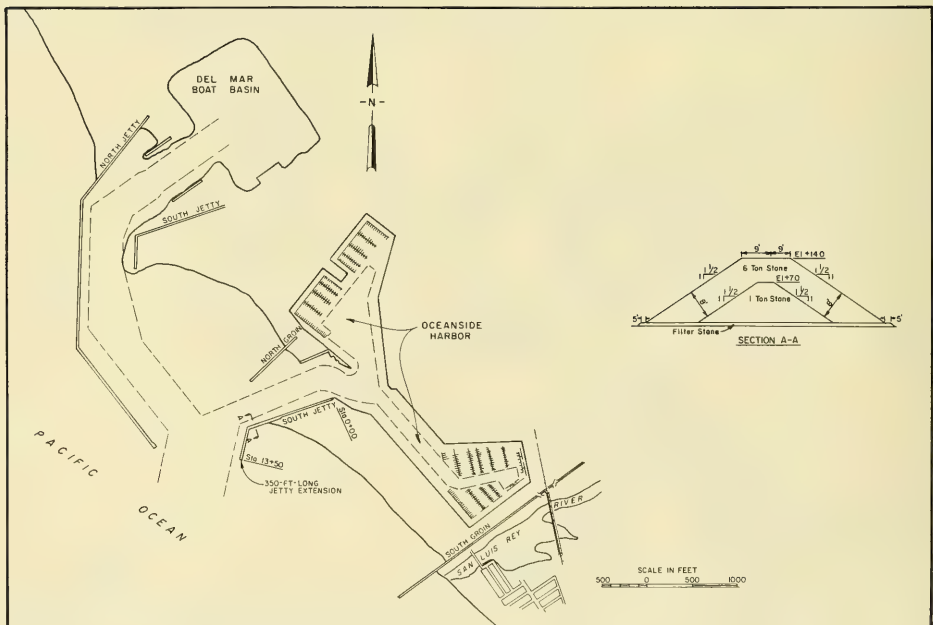
Figure 33. Oceanside Harbor, California

<u>Date(s)</u>	<u>Construction and Rehabilitation History</u>
1958	Construction of the Del Mar Boat Basin (formerly Camp Pendleton Harbor) was completed by the US Navy. The north and south jetties at the basin entrance also were constructed and are maintained by the Navy.
1961	The construction of a 1,000-ft-long rubble-mound south jetty at the entrance to Oceanside Harbor (south of Del Mar Boat Basin) was completed (Figure 33). The jetty had a crest el of +14 ft mllw and a width of 18 ft. Side slopes were 1V:1.5H.
1968	Construction of a 350-ft-long rubble-mound extension to the south jetty was completed. In addition, the existing jetty was sealed from sta 3+70 to 12+10 in an effort to minimize shoaling of the entrance channel. Grout holes were drilled through the armor stone and penetrated the core by 1 to 2 ft. Grout then was pumped in the holes under pressure to seal the structure.
1986	The jetty is in satisfactory condition.

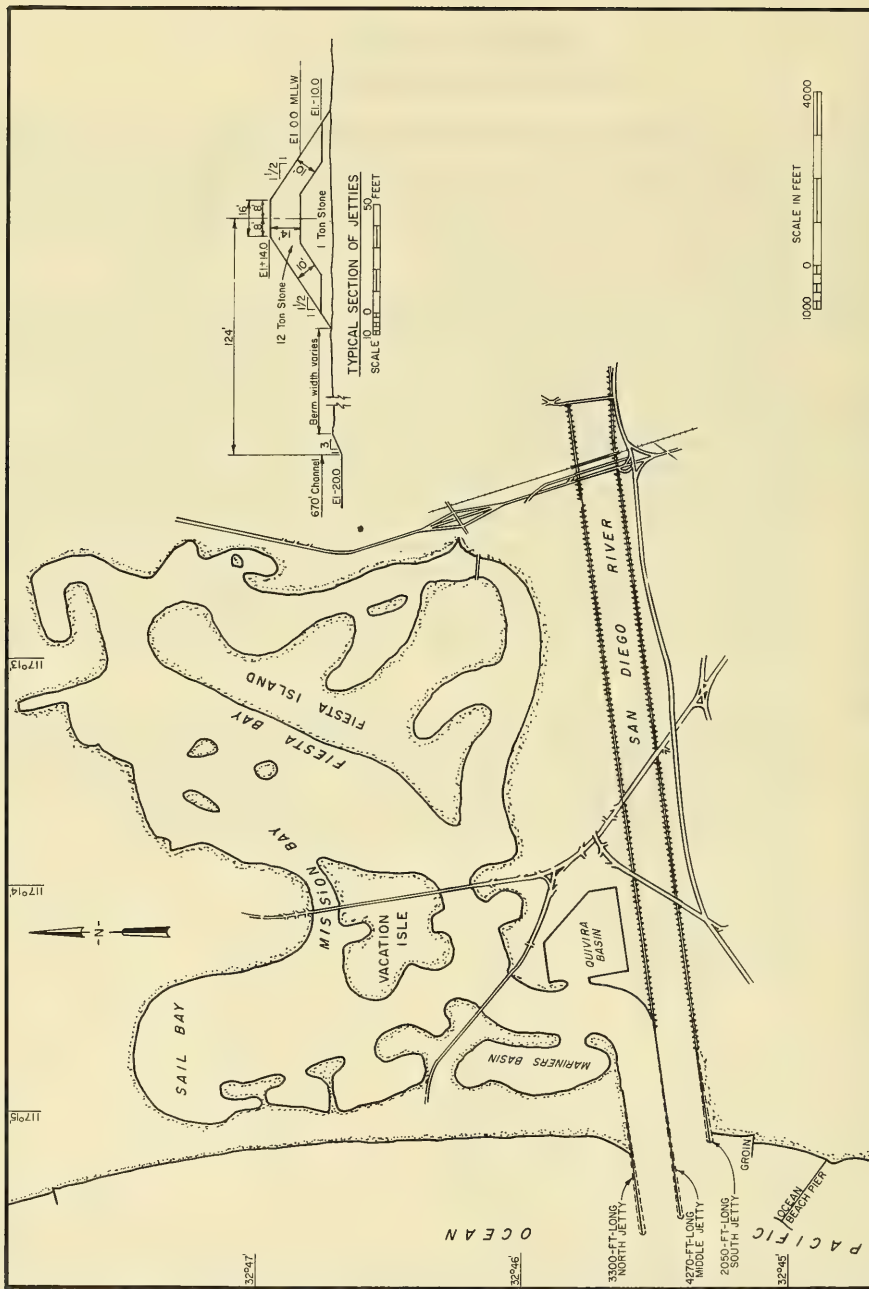
Figure 34. Mission Bay Harbor, California

<u>Date(s)</u>	<u>Construction and Rehabilitation History</u>
1949	Construction of three rubble-mound jetties at the site (Figure 34) was completed. These structures included a 3,300-ft-long north jetty, a 4,270-ft-long middle jetty, and a 950-ft-long south jetty. Typically, the jetties were built with a 16-ft-wide crest at an el of +14 ft mllw with side slopes of 1V:1.5H.
1955	Sediment from the littoral zone was noted passing through the north jetty into the entrance channel. Sealing stones (3,000 tons) were placed on the seaward slope of the jetty. This measure retarded the movement of sand but did not entirely stop infiltration.
1959	Approximately 1,300 ft of the middle jetty and 1,000 ft of the north jetty were sealed with grout to prevent the movement of sediment through the structures. The original core stone of the jetties was constructed at el 0.0 ft mllw. The intruded grout barrier was installed to el +6 ft mllw. The cost of this work was \$78,900.

1970	A 1,100-ft-long extension and sealing of the south jetty were completed. Jetty sealing was accomplished by installing a 3-ft layer of sealing stone in the littoral zone. The head of the middle jetty also was repaired in that the cover stone (12-ton) at the head of the jetty was restored. Total cost of the work was about \$566,000.
1986	The existing jetties currently are in satisfactory condition. Design has been completed for an offshore breakwater located seaward of the north and middle jetties that will provide additional wave protection for Mission Bay Harbor. The proposed offshore breakwater has been model tested (Curren 1983, Markle 1983, Bottin and Acuff 1985) but not yet constructed in the prototype.

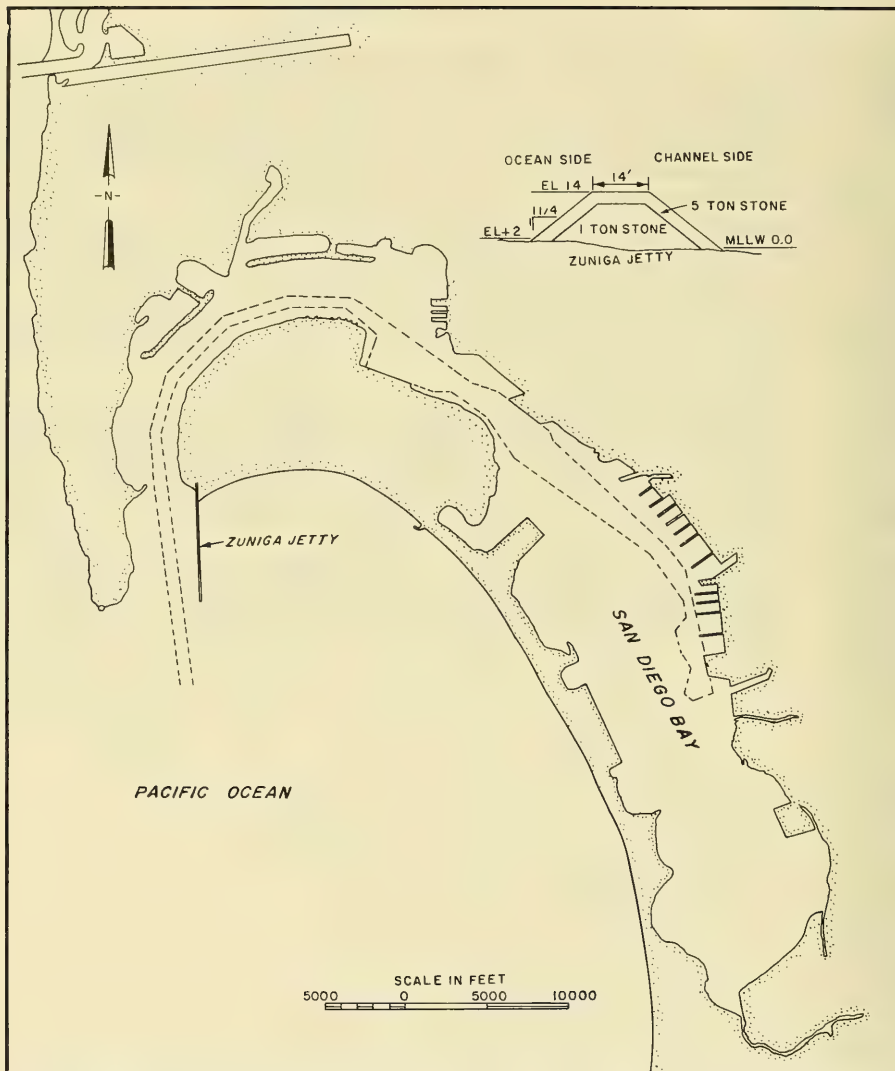
Figure 35. San Diego Harbor, California

<u>Date(s)</u>	<u>Construction and Rehabilitation History</u>
1894- 1902	Construction of a 7,500-ft-long rubble-mound jetty (Zuniga Jetty) was completed (Figure 35) during this time frame. The design height of the jetty was +14 ft mllw with a 14-ft-wide crest. Side slopes were 1V:1.25H. It is indicated, however, that the jetty was not constructed to the full design height.
1942	Rehabilitation work was performed by the US Navy from the shoreward end to a point about 1,400 ft seaward.
1943- 1969	Settlement and flattening of the slopes occurred, particularly in the outermost third of the jetty. As a result, parts of the jetty were awash or submerged at most tide stages, creating hazards to navigation.
1970	Maintenance repair of the jetty was accomplished for a cost of approximately \$127,000. This work consisted of the construction of platforms on the jetty for navigation lights which were installed by the US Coast Guard to alleviate hazards to navigation.

1984	Maintenance repair of the jetty was completed, the extent of which is unknown.
1986	Even though the jetty was not constructed to full design height, it functions satisfactorily as a training wall which concentrates tidal flows and keeps the entrance channel scoured to project depth.
